**Catheter intervention to
treat migrated
temporary epicardial
pacing wire into the
pulmonary artery**

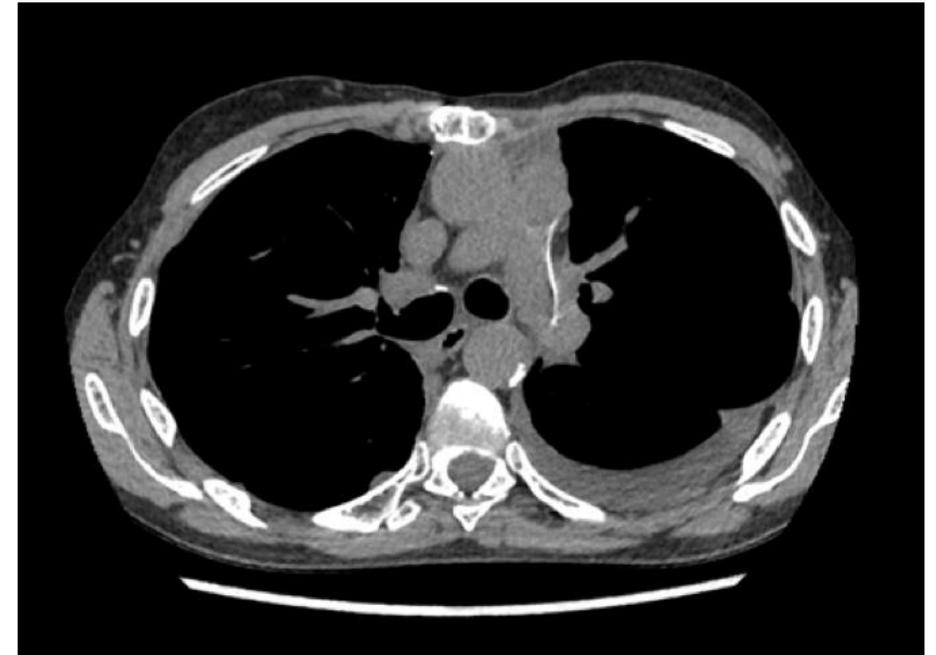
Figure 1.

- During routine follow-up exams, a Computerized Tomography (CT) Scan showed the presence of a hyperintense signal in the region between the right atrium and the right ventricle, crossing the tricuspid valve, with a final loop in the right ventricle infundibulum, suspected to be a TEPW. (Figure 1)

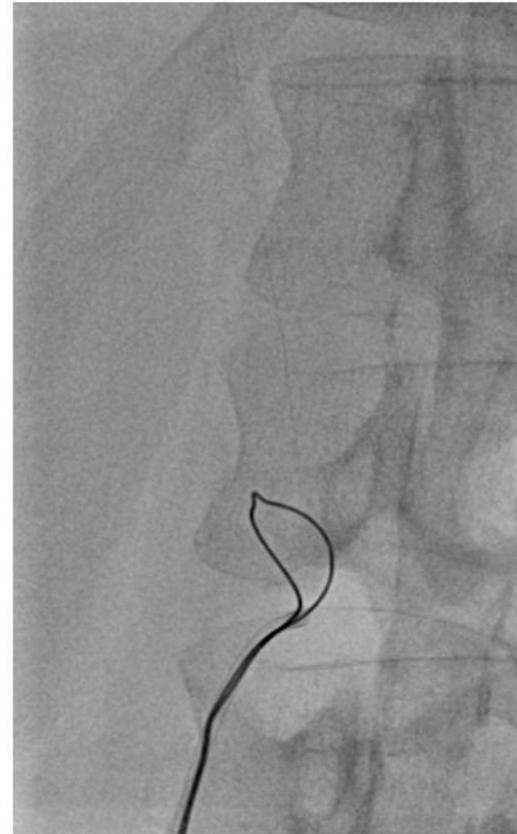
Figure 2.

- A fluoroscopy showed the presence of a metallic wire divided into two segments, the former extended from the right atrium till the right subclavian vein passing through the superior cava vein; the latter extended from the right ventricle till the left pulmonary artery.
- The patient underwent a transcatheter intervention with a right femoral vein access, to try to remove the TEPWs. The former located in the right atrium had an extravascular location, so it was left inside. The other one was removed.
- After advancing a Swan- Ganz catheter into the pulmonary artery, it was exchanged with a multipurpose catheter and a Multi-Snare 20 mm retrieval system (Figure 2) captured the wire and dragged till the inferior cava vein; a second retrieval system, a Snare STD 12-20 mm (Figure 3), was finally able to anchor firmly the wire and to carry it outside.
